Is the 8-mm robotic port safe? A case of trocar site hernia after robotic cholecystectomy using the da Vinci Xi system

Videosurgery Miniinv 2019; 14 (1): 137–140
DOI: <https://doi.org/10.5114/wiitm.2018.76263>

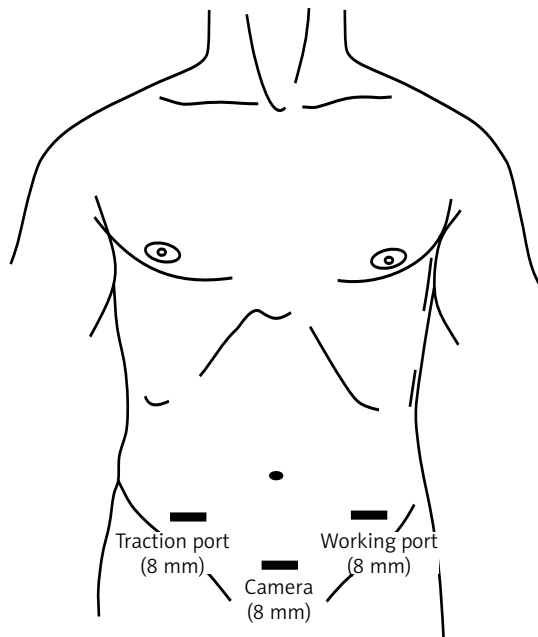
Figure 1. Three robotic cholecystectomy port sites. The 8-mm trocars were inserted through the bikini-line incision (right, middle, and left lower quadrant abdominal areas with transverse incision)

A 37-year-old woman (informed consent was obtained) was diagnosed with calculous cholecystitis on abdominal sonography. There was no bile duct stricture or stone on magnetic resonance cholangiopancreatography. Her body mass index (BMI) was 30.2 kg/m², and she had no significant medical history except for 2 cesarean deliveries. She underwent robotic cholecystectomy with the bikini-line incision technique in which ports are placed as described in Figure 1 (8-mm port at the right, middle, and left

lower quadrants) [1]. The operative time was 75 min, with no drainage or intraoperative complications. After the specimen was retrieved from the mid-lower incision site, no fascial closure was performed. The patient was discharged 2 days postoperatively, after an uneventful recovery. Later on the day of discharge,

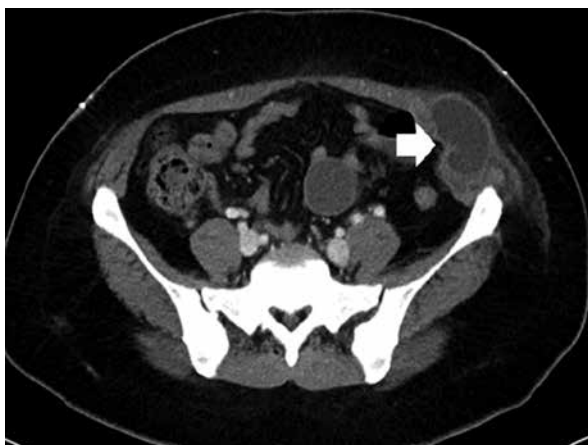
Photo 1. Arrow on the abdominal computed tomography image showing a loop of the small bowel herniating through a defect of fascial and peritoneal layers at the left 8-mm port site

the patient presented to the emergency room with complaints of left incision site pain, a distended abdomen, and 2 episodes of vomiting since discharge. Physical examination showed tenderness in the left lower quadrant with a 3-cm palpable mass above the 8-mm port-site scar. There was no sign of peritonitis. All hematological and biochemical workups were within normal limits. Abdominal radiographs showed no sign of obstruction in the small and large bowel loops. Computed tomography of the abdomen revealed small bowel obstructions secondary to dilated fluid-filled herniated loops through abdominal fascial and peritoneal layers at the 8-mm port site (Photo 1). After 5 days of conservative treatment and failure to resolve the mechanical ileus, the patient underwent emergency diagnostic laparoscopy. The herniated loop was twisted and obstructed within the fascial defect (Photo 2). The loop was delivered after the defective fascial and peritoneal layers were carefully dissected. Gangrenous changes were present at the part of the loop adherent to the defective area. The gangrenous part of the small bowel loop was kept under a warm saline-soaked sponge while the patient was given 100% oxygen for approximately 5 min. However, the color and peristalsis of the gut loop did not significantly improve. Therefore, bowel resection and anastomosis of the ischemic area were performed through a small laparotomy incision near the umbilicus. The abdominal herniation site was closed in layers, allowing proper anatomical repair of the fascia and peritoneum. The patient remained in good condition during the postoperative period and was discharged without further complications.

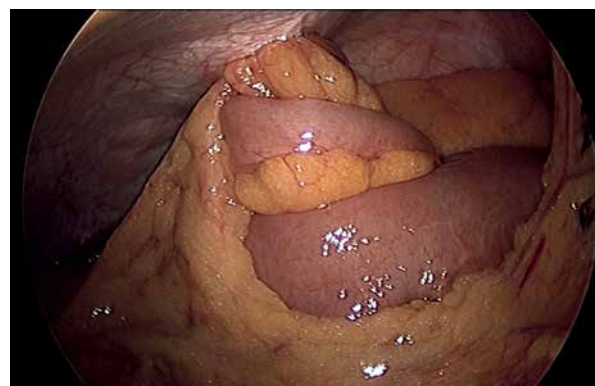
Photo 2. Laparoscopic picture showing a small bowel loop twisted and herniated through the left 8-mm port site

At our institute, approximately 100 robotic cholecystectomies using the da Vinci system have been performed by a single surgeon, and this was the only case of TSH involving the 8-mm port site at a non-midline incision. We believe that the TSH might have occurred for the following reasons. First, obesity may be a risk factor for TSH. The da Vinci Xi system uses pivoting point remote center technology. The robotic arm moves around a fixed “remote center” located on the fascial layer; thus, reducing trauma to this layer is an important factor for TSH. However, if the remote center of the robotic port is distant from the fascial layers, the robotic arm can

damage the fascia around the port, resulting in an unintended larger defect. In patients with obesity, it is difficult for surgeons to detect the location of the fascial layer where the remote center should be fixed. Moreover, with pivoting action, the higher the BMI is, the larger is the peritoneal defect. Second, the working port itself may increase the risk of hernia. In this case, the herniation occurred on the left side (Photo 1) and involved the left working port. The robotic arm for the working port conducts more technically demanding procedures while the arm for gallbladder traction moves with the working port. This movement leads to further stretching and traumatization of the abdominal wall and fascial and peritoneal layers. Third, the prone position of the robotic arm may also have been a risk factor for TSH in our case. We adapted the robotic cholecystectomy with the bikini-line incision technique for cosmesis and pain relief [1]. However, all the port sites were far from the gallbladder and the robotic arms should have been properly laid down to reach the operative field. This position may lead to inappropriate location of the robotic port and cause a larger fascial defect.
